Failure Analysis Final Report

27199

End Customer: CISCO

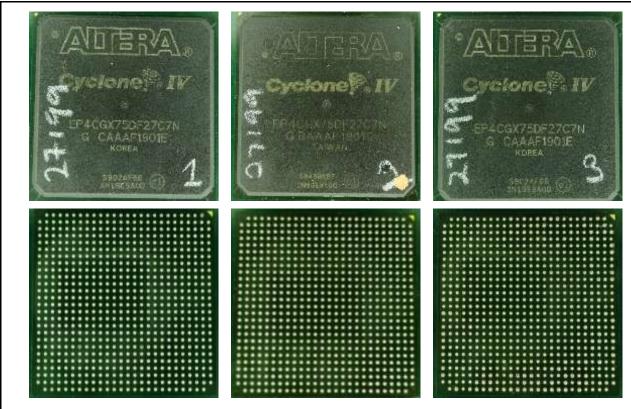
At visual inspection, the solder balls of the devices were found to be deformed as expected after device extraction from customer's board (Figure 1).

Figure 1: Top and bottom view of incoming ERMA devices.

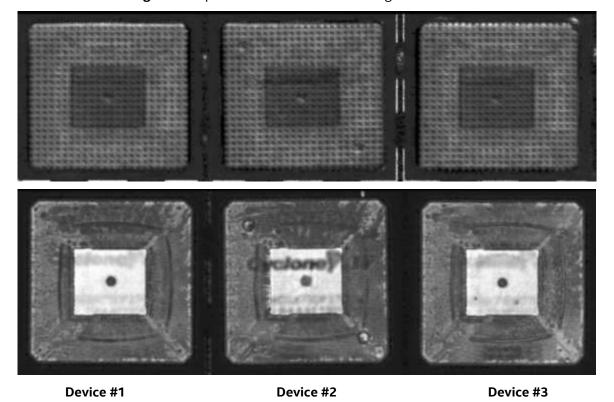
C-SAM inspection was performed on the returned devices and no anomaly were observed. (Figure 2)

Figure 2: C-SAM inspection on incoming ERMA devices.
