Using Cyclone V HMCPHY DQ pins as high frequency inputs

I am working on a design that uses two 500MSps ADCs with a DDR interface clocked at 250MHz. The ADC supplies the 250MHz clock to clock the signals into the FPGA. I am using the ALTDDIO_IN IP block to clock the DDR signal into the FPGA. This results in a DATA_l and a DATA_h signal which is processed in two parallel paths. This is working without timing problems for one of the ADCs.

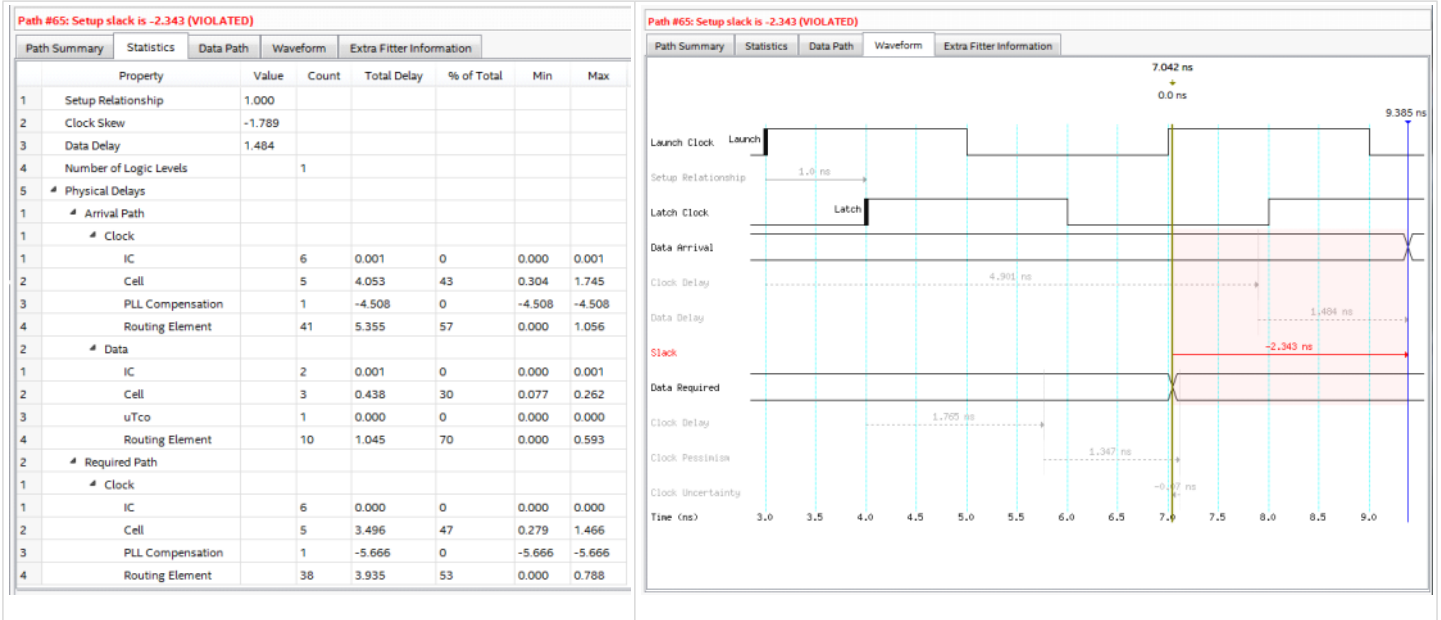
ADC_DI_DDR_data_h[3] (not a HMC pin) to VectorRegister[3]:

Without setting any additional constraints there are a lot of timing issues due to the fact that Quartus tries to accommodate for a latch edge that is 1ns after the launch edge. The waveforms for the signals shown above are now:

Based on the negative slack of -4.9 ns one could argue that moving the Latch edge by 4.0 ns will not solve the problem for the signal using the HMC pin. It would be sufficient for the ADC_DI_DDR_data_h[3] signal which has a negative slack of -2.343 ns.

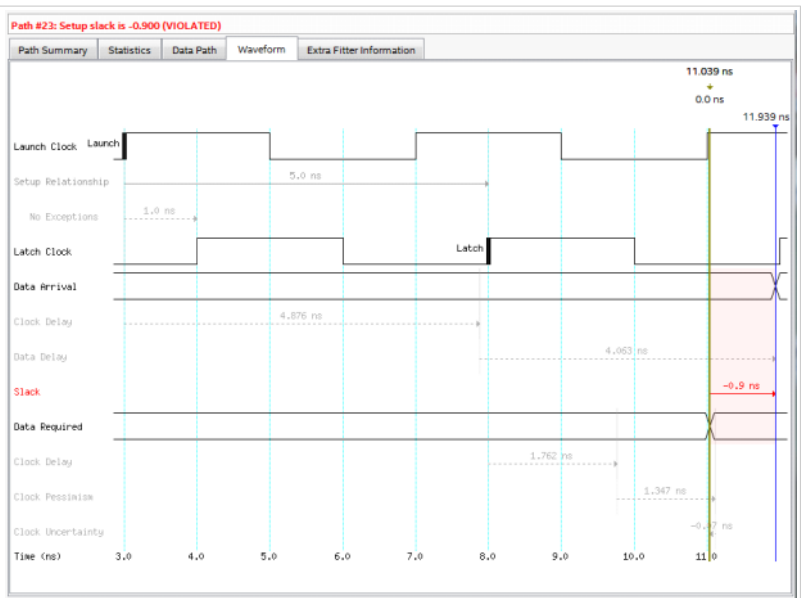
ADC_DI_DDR_data_h[4] (HMC pin) to VectorRegister[4]:

Path #23: Setup slack is -0.900 (VIOLATED)

Property	Value	Count	Total Delay	% of Total	Min	Max
1 Setup Relationship	5.000					
2 Clock Skew	-1.767					
3 Data Delay	4.063					
4 Number of Logic Levels		1				
5 Physical Delays						
1 Arrival Path						
1 Clock						
1 IC	6	0.000	0	0.000	0.000	0.000
2 Cell	5	4.053	43	0.304	1.745	
3 PLL Compensation	1	-4.508	0	-4.508	-4.508	
4 Routing Element	41	5.331	57	0.000	1.056	
2 Data						
1 IC	2	0.000	0	0.000	0.000	0.000
2 Cell	3	0.438	11	0.077	0.262	
3 uTco	1	0.000	0	0.000	0.000	
4 Routing Element	13	3.625	89	0.000	2.182	
2 Required Path						
1 Clock						
1 IC	6	0.000	0	0.000	0.000	0.000
2 Cell	5	3.496	47	0.279	1.466	
3 PLL Compensation	1	-5.666	0	-5.666	-5.666	
4 Routing Element	38	3.932	53	0.000	0.788

This indicates that the timing for the HMC pin might not be met. It might be necessary to shift the Latch clock with 180 Degrees instead of 90 Degrees to solve the remaining negative slack of -0.9 ns.

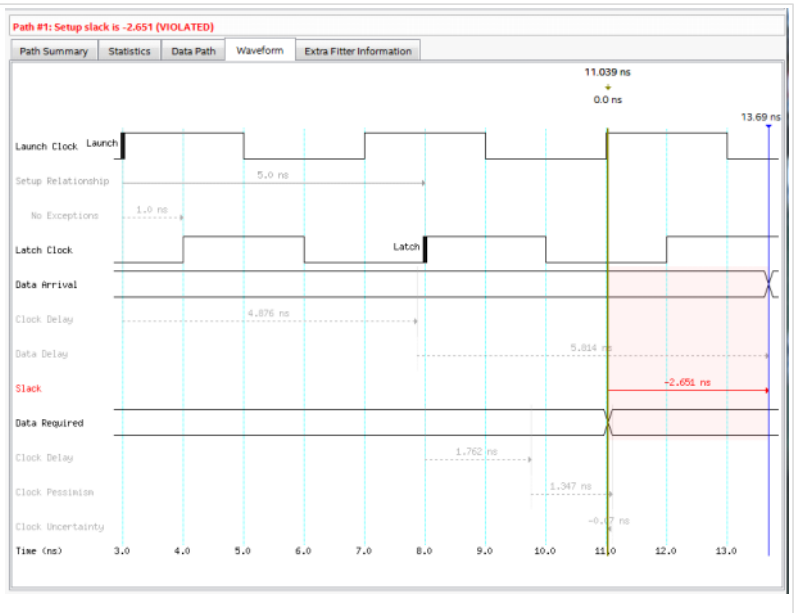
ADC_DI_DDR_data_h[4](HMC pin) to VectorRegister[4]:

Path #1: Setup slack is -2.651 (VIOLATED)

Path Summary	Statistics	Data Path	Waveform	Extra Fitter Information		
Property	Value	Count	Total Delay	% of Total	Min	Max
1 Setup Relationship	5.000					
2 Clock Skew	-1.767					
3 Data Delay	5.814					
4 Number of Logic Levels	0					
5 Physical Delays						
1 Arrival Path						
1 Clock						
1 IC	6	0.000	0	0.000	0.000	
2 Cell	5	4.053	43	0.304	1.745	
3 PLL Compensation	1	-4.508	0	-4.508	-4.508	
4 Routing Element	41	5.331	57	0.000	1.056	
2 Data						
1 IC	1	0.000	0	0.000	0.000	
2 Cell	2	0.658	11	0.099	0.559	
3 uTco	1	0.000	0	0.000	0.000	
4 Routing Element	17	5.156	89	0.000	2.182	
2 Required Path						
1 Clock						
1 IC	6	0.000	0	0.000	0.000	
2 Cell	5	3.496	47	0.279	1.466	
3 PLL Compensation	1	-5.666	0	-5.666	-5.666	
4 Routing Element	38	3.932	53	0.000	0.788

For this signal the Data Delay also increased. The calculation in TimeQuest before rebuild showed a negative slack of -0.9 ns. With the build this increased to -2.651 ns.
