Intel® Xeon® Processor 3500 Series

Specification Update

February 26, 2010

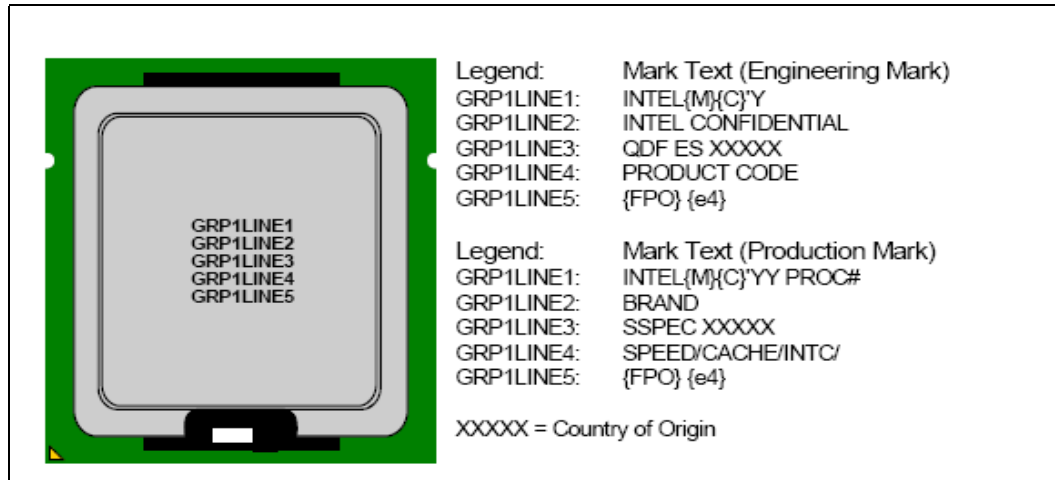
Figure 1. Processor Top-side Markings (Example)

Intel® Xeon® Processor 3500 Series stepping can be identified by the following component markings:
